# An Unexpected Intermittent Repetitive Audible Alert Just After Replacement of an Implantable Cardioverter-Defibrillator

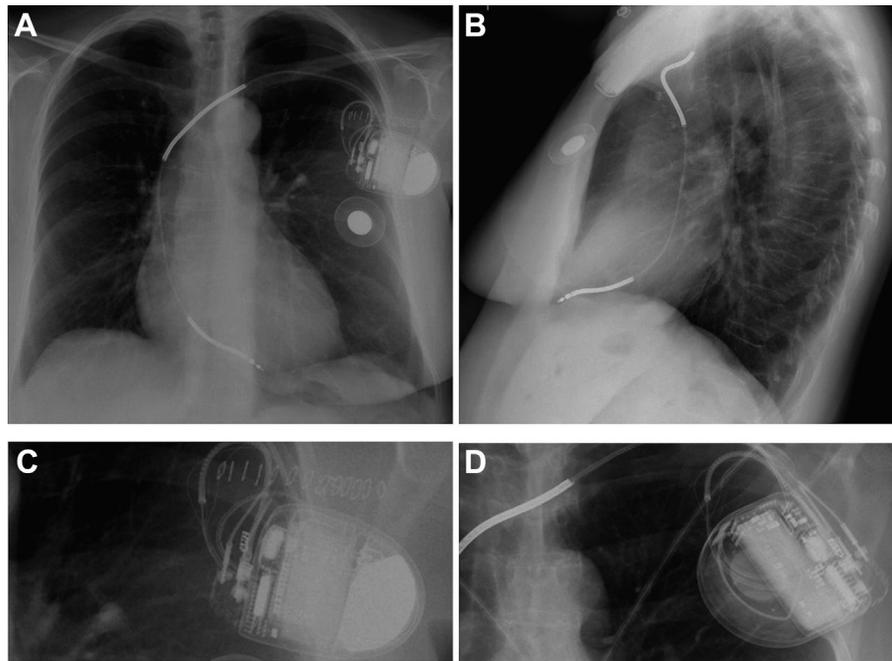
**FIGURE 1** Chest Radiographs After and Before ICD Generator Replacement

A chest radiograph revealed a radiopaque object just below the ICD (**Figures 1A and 1B**), which corresponded to a magnetic port of the tissue expander. Thus, the phenomenon was due to the close proximity of the generator to the magnetic port of the breast tissue expander, which led to transient magnet interference in the ICD. After ICD replacement in the same pocket, the position of the new generator (**Figure 1C**) was slightly different from the previous one (**Figure 1D**), and as a result, in the forward-leaning position, the magnetic port came close enough to the ICD to cause magnetic interference, which triggered the audible tone, something that did not happen with the previous implantation. In patients with cardiac implantable electronic devices, the magnet port of some breast tissue expanders can produce device interference that enables a magnetic response of the device (tachycardia detection is suspended in all ICDs, and hence, no anti-tachycardia therapy occurs), which puts patients at risk. Alternative breast tissue expanders with no magnetic port exist and should be placed in these patients.

Posteroanterior (A) and lateral (B) chest radiographs after ICD generator replacement. Detail of the posteroanterior chest radiograph showing the orientation of the generator after (C) and before (D) ICD replacement. ICD = implantable-cardioverter defibrillator.
